INVESTIGATION OF SOIL CONTAMINATION AT LEAD BATTERY RECYCLING PLANTS IN DOUALA CAMEROON

Occupational Knowledge International (OK International)

Centre de Recherche et d'Education pour le Développement (CREPD)

October 2023

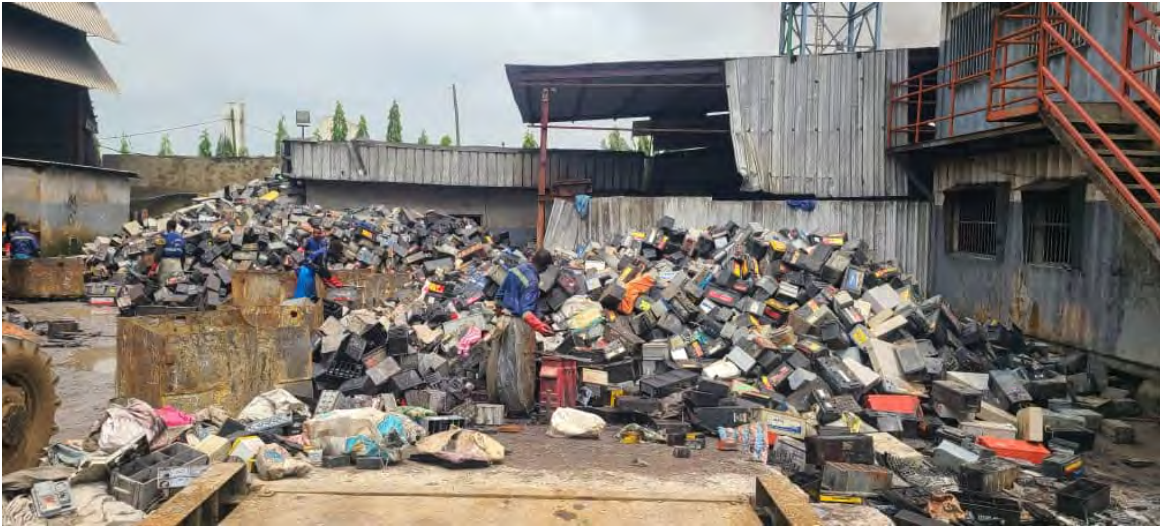
- At all the three plants, discarded batteries are kept in piles outdoors and/or in the hangar on a concrete surface with no precautions to collect the leaking acid.

Figure 1. ULABs storage and battery breaking area at METAFRIQUE Cameroon SA.

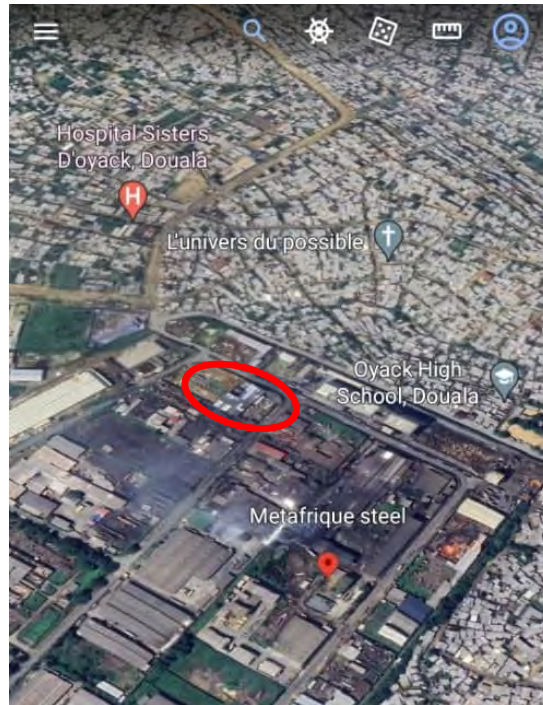
- The METAFRIQUE Cameroon SA and KYSEN Global Sarl facilities are located adjacent to residential areas.
- The GANESHA Cameroon Sarl site is surrounded by agricultural fields and adjacent to a food and beverage company.

Figure 2. METAFRIQUE Cameroon SA (red circle) is located in a densely populated residential area of Douala City. Google Earth (2023) *Douala* <https://earth.google.com/web/> (Accessed: 18 July 2023).

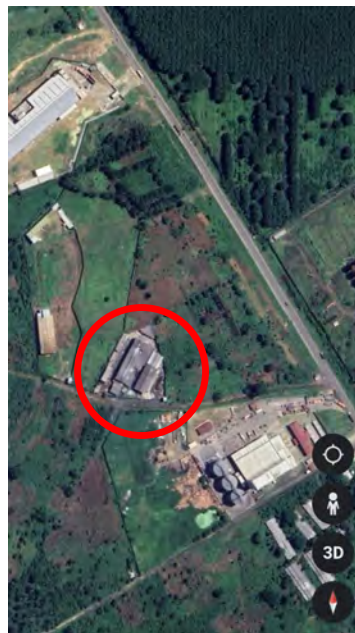
Figure 3. GANESHA Cameroon Sarl (red circle) plant located in an agricultural area. Google Earth (2023) *Douala* <https://earth.google.com/web/> (Accessed: 18 July 2023).

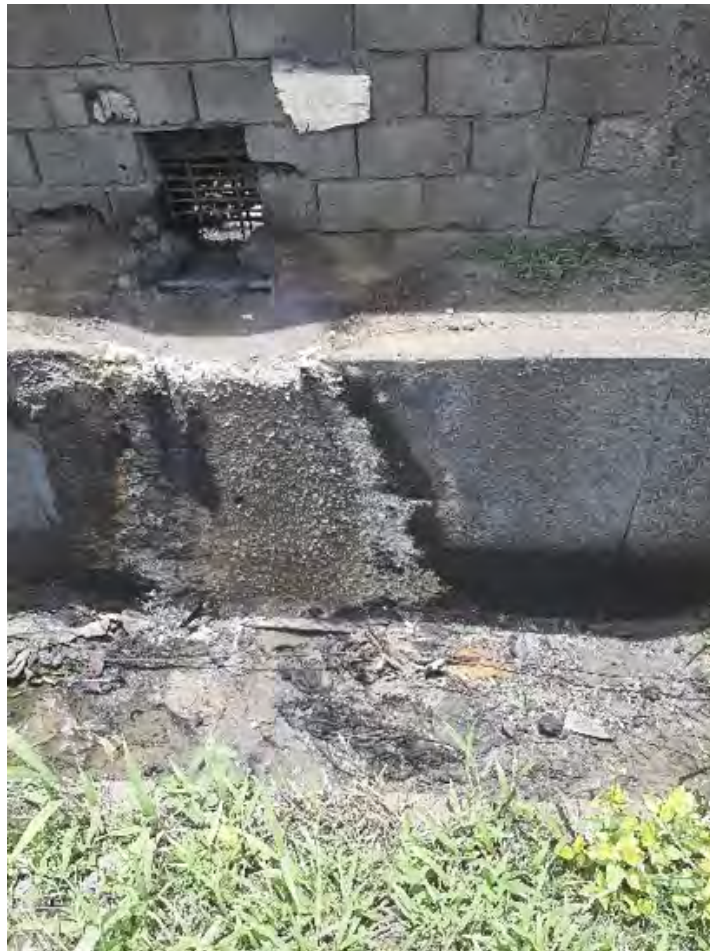
- At all the three plants there is no effluent treatment plant to treat acidic waste or runoff before it is released into the environment.

Figure 4. Untreated effluent discharged into an adjacent residential area outside of METAFRIQUE Cameroon SA. Note the corrosive effect of the acidic effluent on the concrete.

Measures urgently needed at the national level include establishing a regulatory level of lead in soil for residential and industrial areas, limiting lead levels in ambient air at lead battery recycling plants, requiring adequate ventilation and pollution controls, stack emission standards, and limits on waste water effluent levels. All new facilities should be required to have a minimum annual throughput capacity to ensure the scale necessary to afford and maintain adequate environmental controls. These measures are needed in order to protect human health and the environment from these ongoing operations. In addition, the extensive soil lead levels identified require remediation to protect these communities.

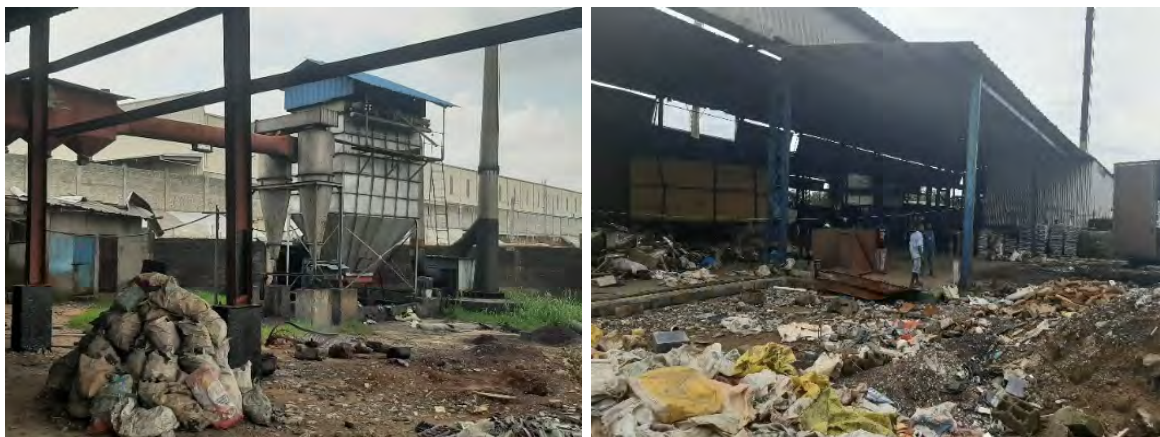
The KYSEN Global Sarl and GANESHA facilities have a baghouse filter on their furnace emissions. However, the METAFRIQUE Cameroon SA facility has no controls in place for furnace emissions. None of these facilities have any ventilation or air filtration system and none operate with negative pressure enclosures. Consequently, releases of airborne lead from the recycling processes, along with fugitive emissions from these substandard facilities are likely to be contributing to airborne emissions and soil lead contamination at levels associated with elevated blood lead levels in children.

Figure 5. Baghouse at KYSEN recycling plant (left) and partial view of the GANESHA Cameroon Sarl plant (right).
